UI Bulletin #138c

Subject: Rear Axle Vent Hose

Models Affected: Chevrolet Silverado
GMC Sierra
Chassis Cab or Box Delete (ZW9) vehicles

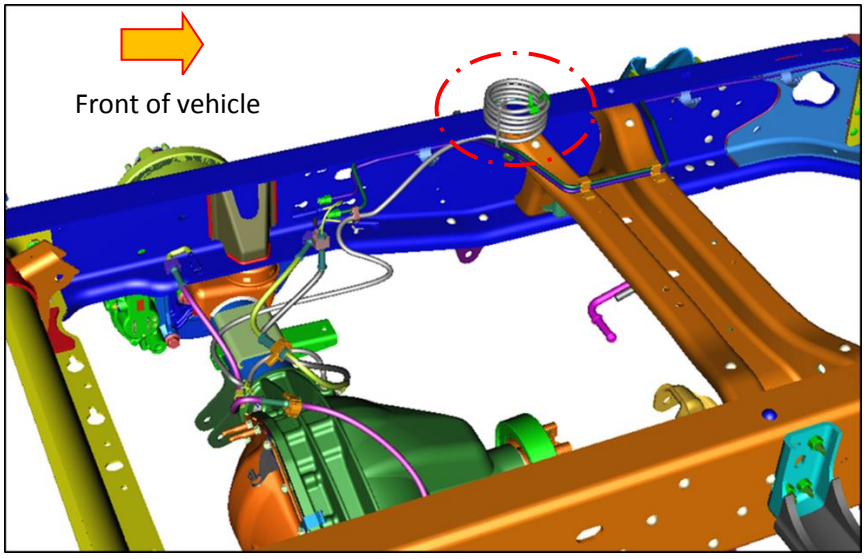
Figure 1 (example)

Chassis Cabs and ZW9 Box delete vehicles are shipped with the rear axle vent tube coiled and secured to the frame (see example in Figure 1)

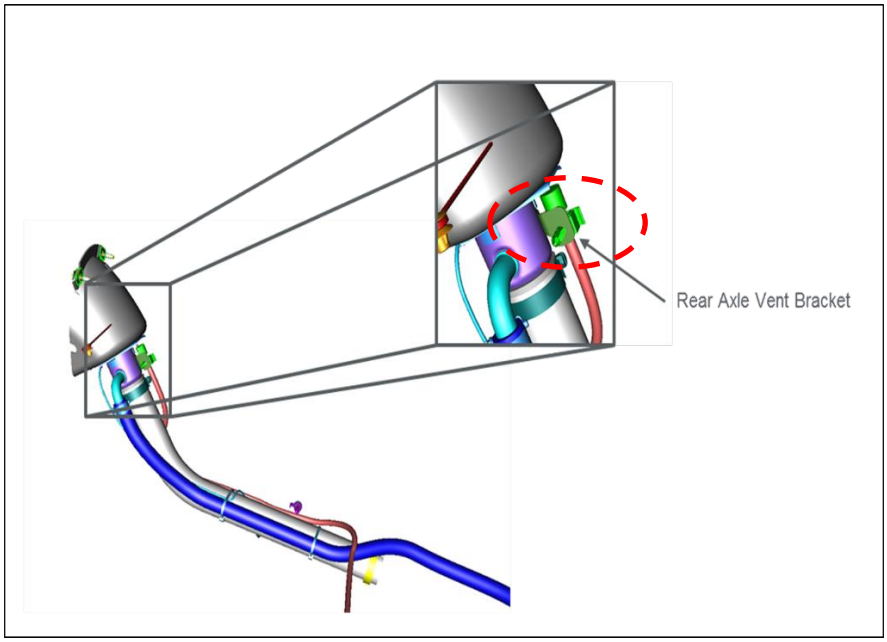
Figure 2

The purpose of this bulletin is to advise upfitters of the requirement(s) to mount the rear axle vent hose in its designated location to prevent water intrusion into the rear axle differential case.

When installing filler neck assembly on a service body be sure to route and secure the rear axle vent tube in the location shown in Figure 2.

When performing a pick up box removal and service body installation, be sure that the rear axle vent hose is secured in the location shown in figure 2. For further information please refer to the vehicle model Special Applications – Pick Up Box Removal Body Builder Manual.

*Note: The Final Stage Manufacturer must elevate the Vent Hose location per their specific upfit to ensure proper function. Relocation / orientation and / or shielding may be required.
